World Trade Center Building Performance Study:

*Data Collection, Preliminary
Observations, and
Recommendations*

FEMA 403 / May 2002

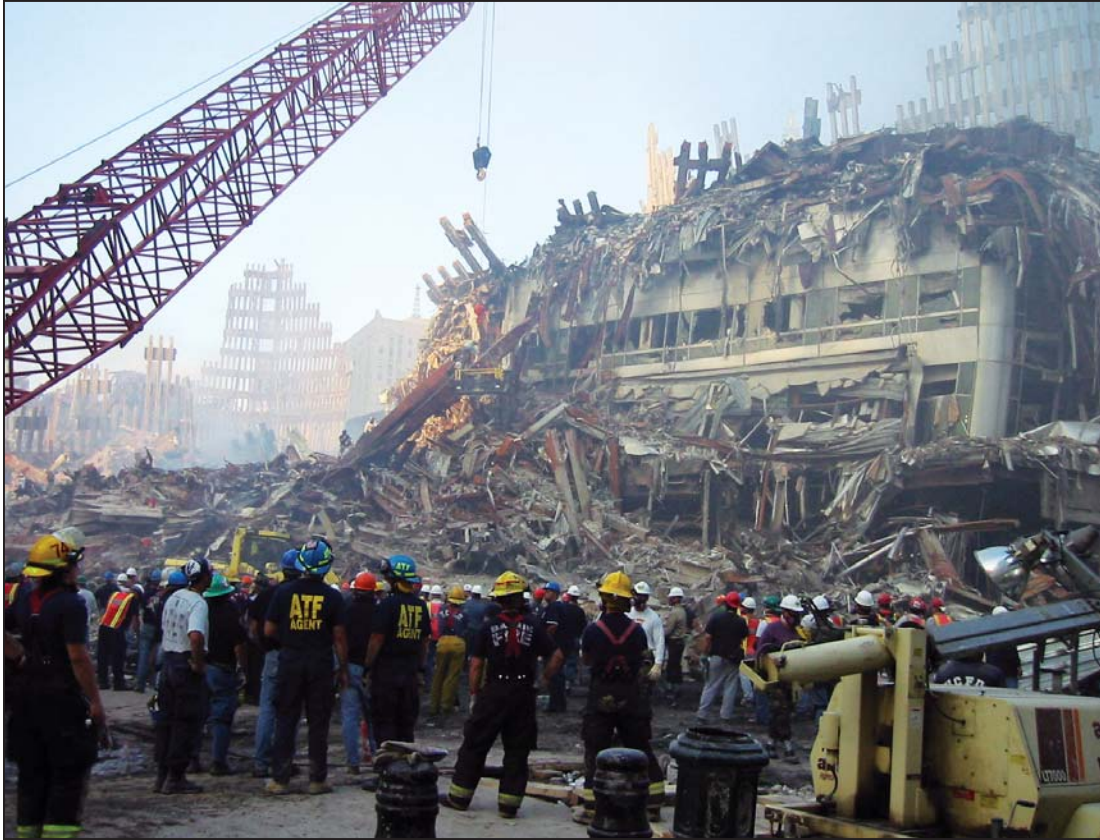
Figure 3-8 Remains of WTC 3 after collapse of WTC 1 and WTC 2.

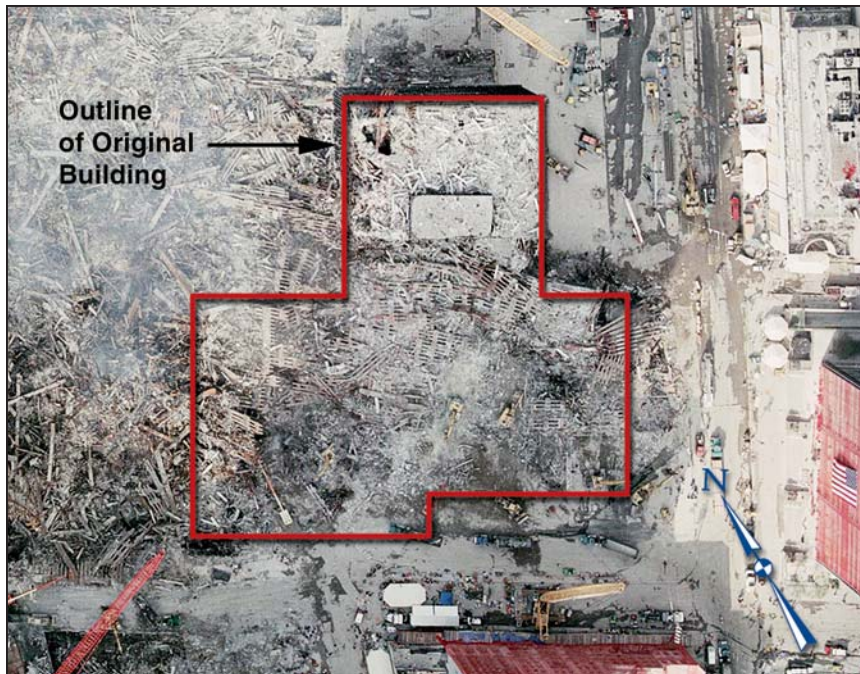
There was major impact to WTC 4 from the collapse of one or both of the WTC towers (most likely WTC 2) that destroyed all but the northern 50 feet of the building. Extensive damage is evident in Figure 4-5.

Figure 4-5 Damage to WTC 4.

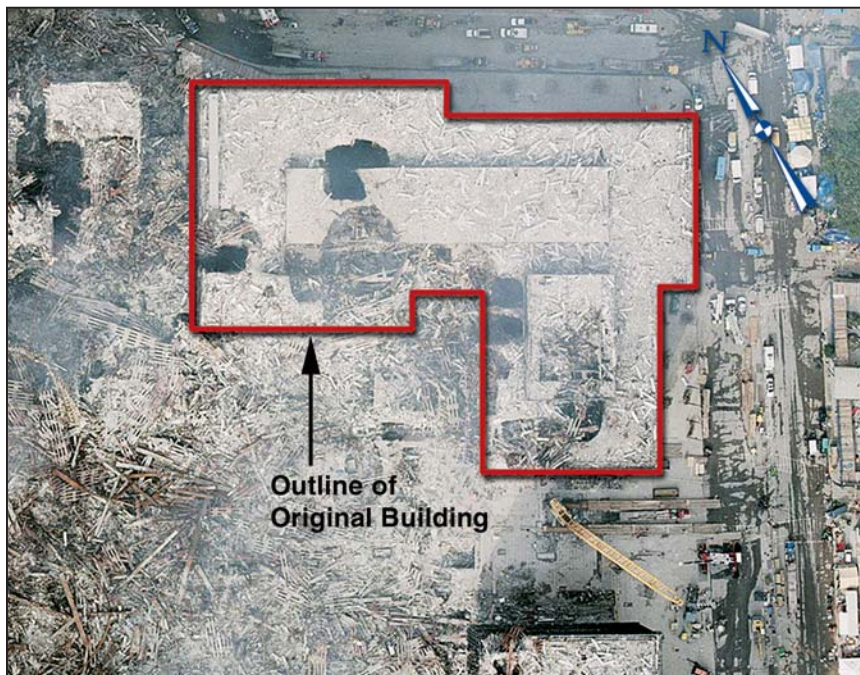
Figure 4-6 Damage to WTC 5.

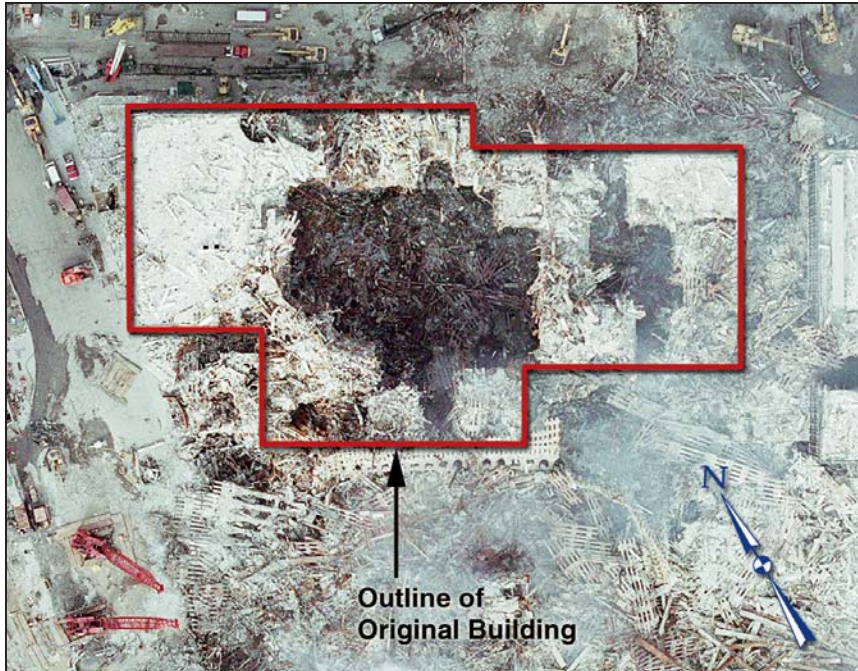
WTC 6 suffered significant impact and fire damage from the collapse of WTC 1, as shown in Figure 4-8. Most of the impact appears to have been in the center of the building, where the damage extended to the ground level. Figures 4-9 and 4-10 illustrate the magnitude of the damage.

Figure 4-8 Damage to WTC 6. Note the edge of WTC 5 on the right hand side.

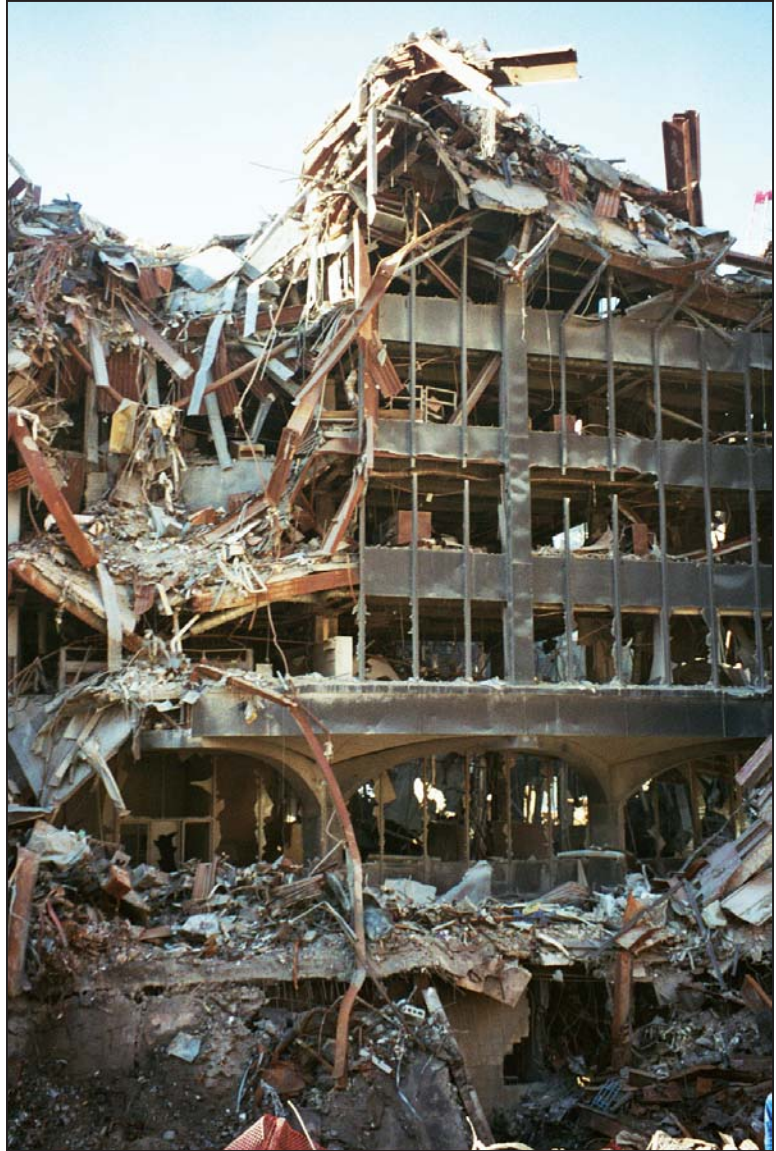
Figure 4-10 Impact damage to the exterior façade of WTC 6.

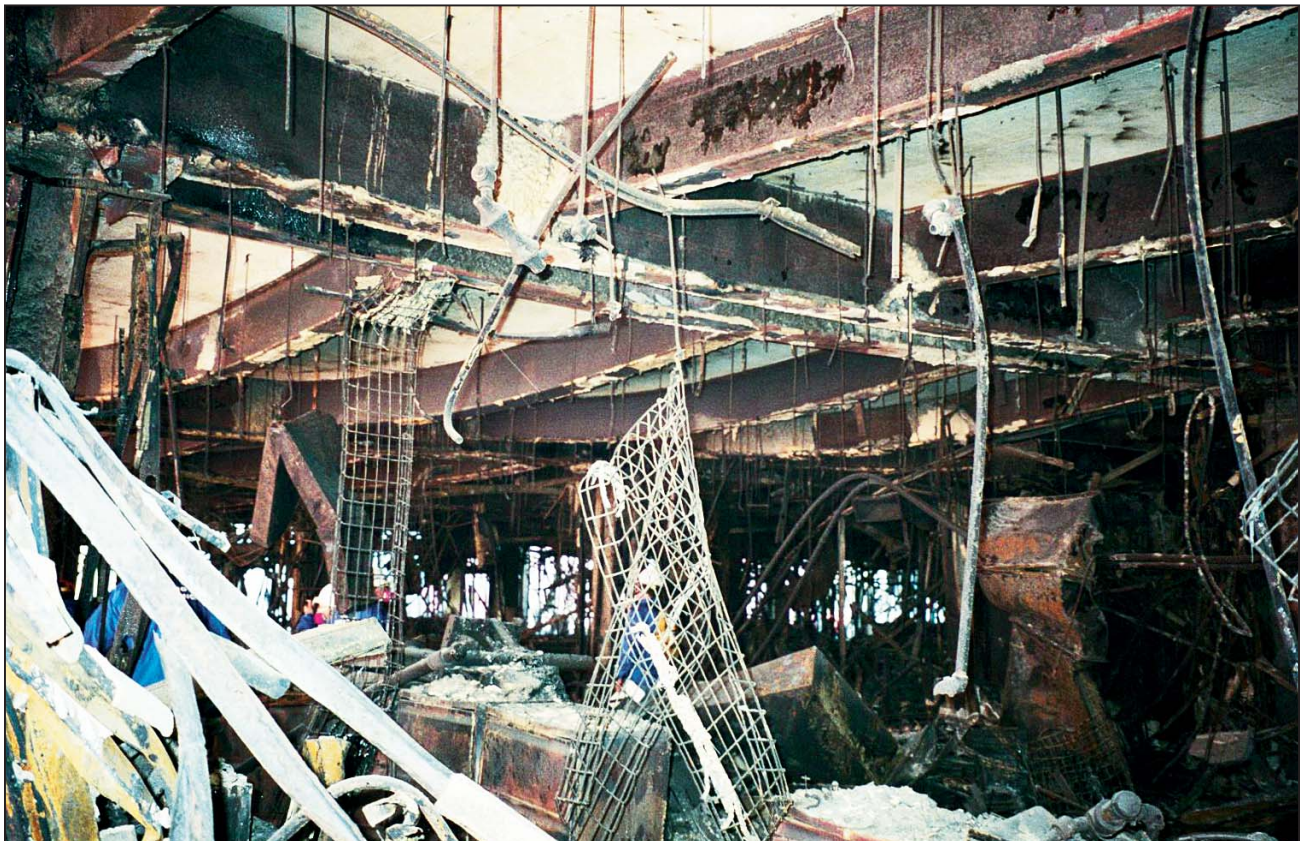
Figure 4-14 Deformed beams in WTC 5.

The steel generally behaved as expected given the fire conditions in WTC 5. Many beams developed catenary action as illustrated in Figure 4-14. Some columns buckled, as shown in Figure 4-17. The one exception is the limited internal structural collapse in WTC 5. The fire-induced failure that led to this collapse was unexpected. As in the rest of the building, the steel beams were expected to deflect significantly, yet carry the load. This was not the case where the beam connections failed. The failure most likely occurred during the heating of the structure because the columns remained straight and freestanding after the collapse.

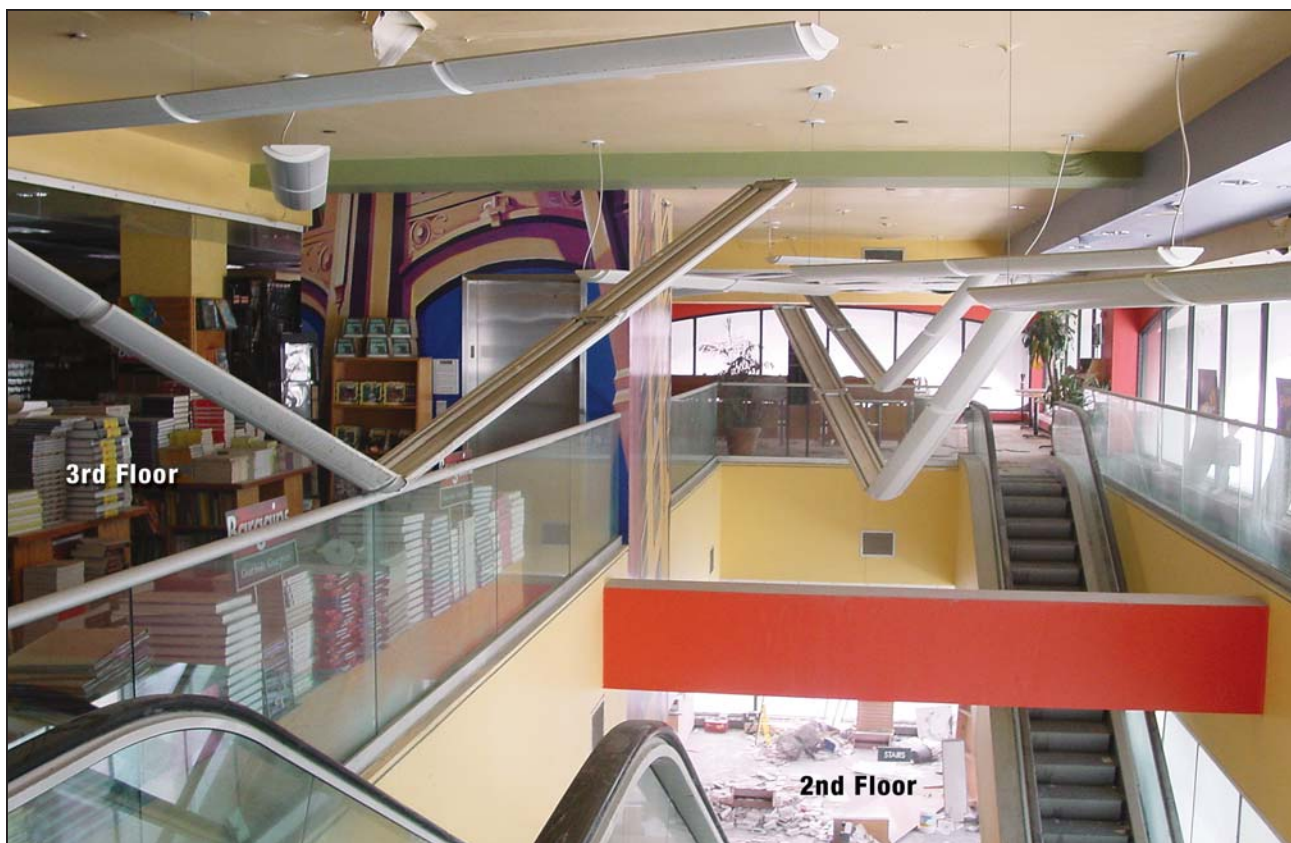
The sprinkler system appears not to have operated at all. This was evident due to the lack of water damage throughout, but especially in the lower level bookstore shown in Figure 4-15. Many sprinkler heads were damaged; some even melted and fell off the sprinkler piping in the fire areas.

Figure 4-15 Unburned bookstore in WTC 5.

The automatic sprinkler system did not control the fires. Some sprinkler heads fused, but there was no evidence of significant water damage, due to a lack of water. This is consistent with the lack of water damage in the bookstore on the lower level and the complete burnout of the upper floors.

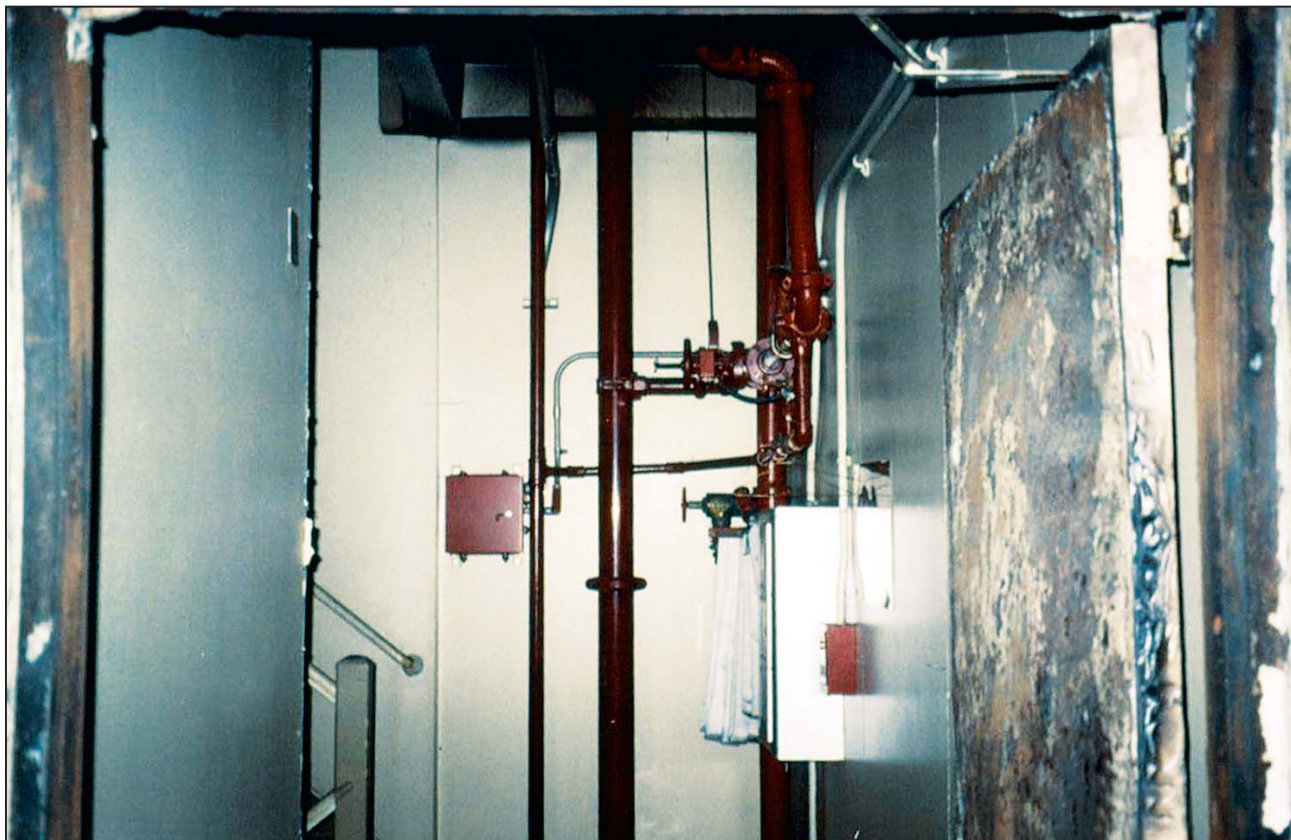
As illustrated in Figure 4-16, the interior of the exit stair tower at the southwest corner was practically untouched by the fire. There were no burn marks or smoke damage in this exit tower, or on the “safe” or stairwell side of the fire door. At one location, a piece of paper was found taped to the exit stairwall just inside the fire door with no evidence of smoke or charring from fire.

Figure 4-16 Looking through the door into the undamaged stair tower in WTC 5.

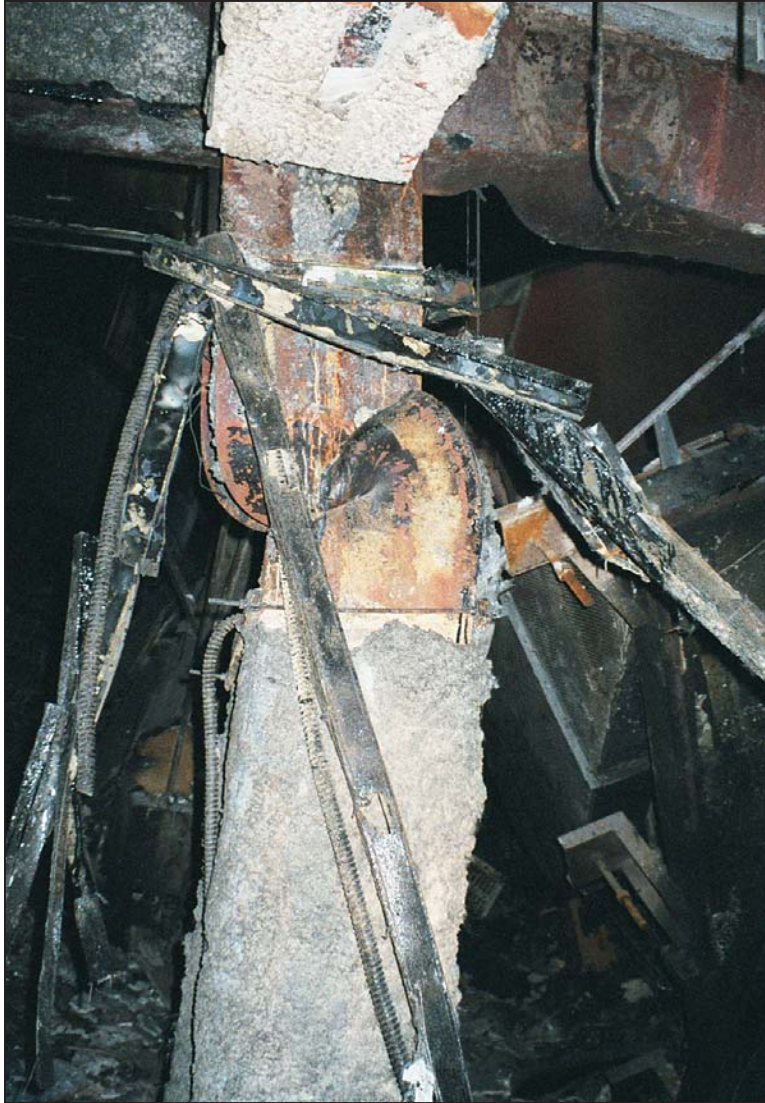
As illustrated in Figure 4-17, there was local buckling of interior columns. This buckling was most likely due to a combination of fire-induced reductions in strength and a possible increase in stress due to restrained thermal expansion. A detailed explanation of these issues is presented in Appendix A, Section A.3.1.4.

*Figure 4-17
Buckled beam flange and column on the 8th floor
of WTC 5 that was weakened by fire.*

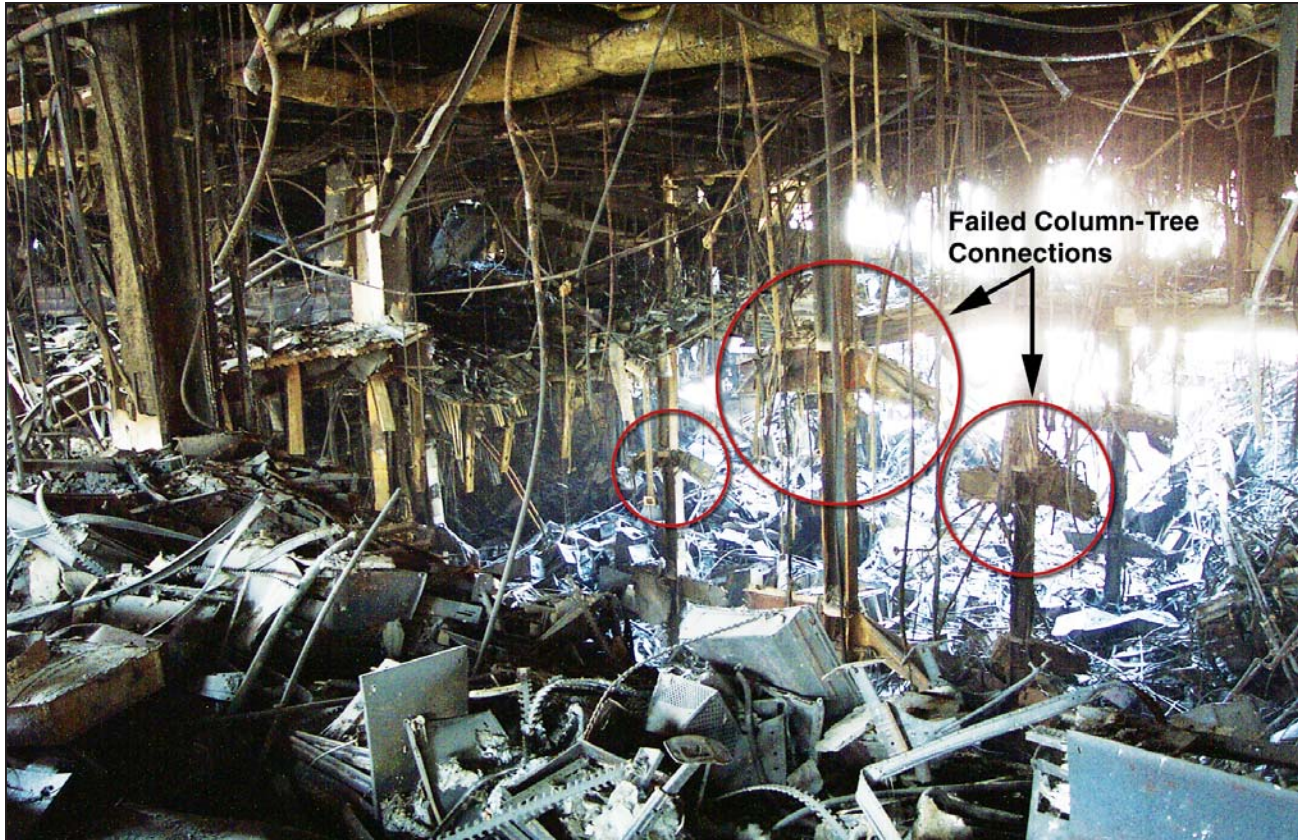
beam stub cantilevers that formed diagonal tension field mechanisms in the cantilever webs and plastic moments at the column, as seen in Figure 4-18.

It is apparent that fire weakened the steel, contributing to the large shear-induced deformations observed in several of the cantilever beams. The shear failures observed at connection ends in several of the beam web samples shown in Figure 4-18 are indicative of the tensile forces that developed. The end bearing resistance of the beam web was found to be less than the double shear strength of the high-strength bolts, based on the analysis presented in Appendix B.

Figure 4-18 Internal collapsed area in WTC 5.

Tensile catenary action of floor framing members and their connections has been neither a design requirement nor a design consideration for most buildings. Further study of such mechanisms for member failures in fires should be conducted to determine whether current design parameters are adequate for performance under fire loads.

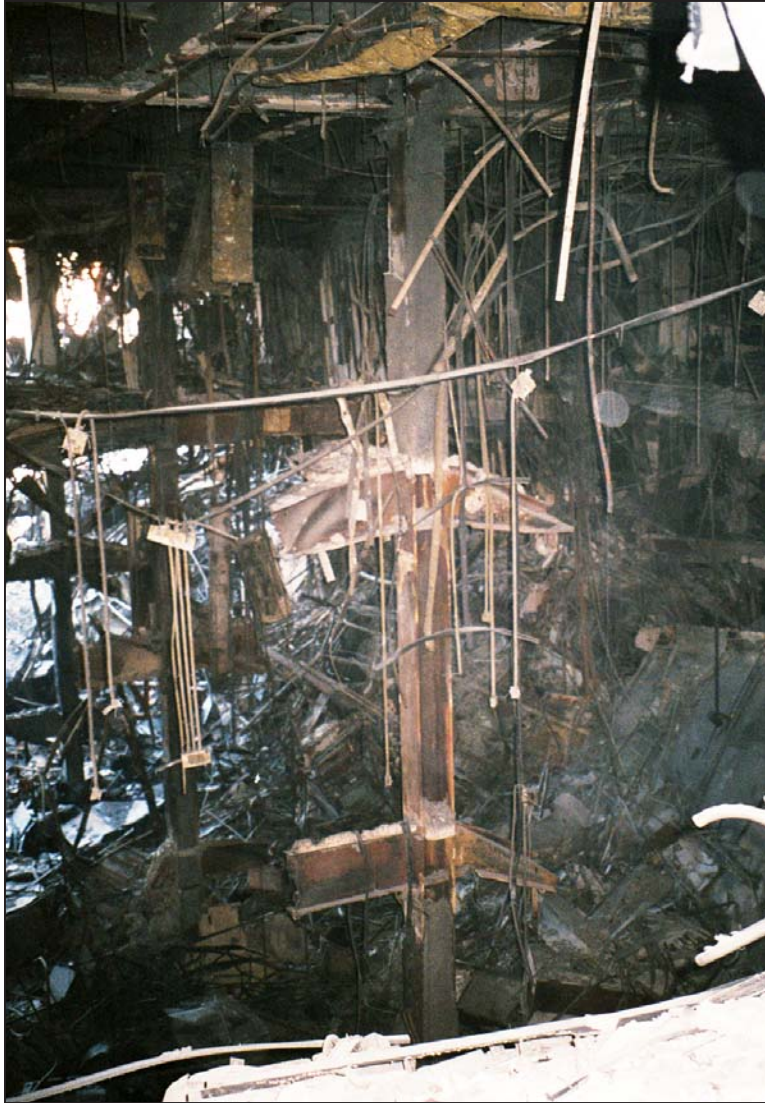
Two areas in WTC 5 experienced local collapse under an intact portion of the roof. Although there was debris impact near this area, the symmetrical nature of the collapse strongly suggests that the failures were due to the uncontrolled fires. This is supported by the observation that the columns in this area remained straight and freestanding (see Figure 4-18). This local collapse appeared to have begun at the field connection where beams were connected to shop-fabricated beam stubs and column assemblies as illustrated in Figures 4-19, 4-20, and 4-21.

Figure 4-19
Internal collapsed area in WTC 5.

The limited structural collapse in WTC 5 due to fire impact as described in Section 4.3.2 appeared to be caused by a combination of excessive shear loads and tensile forces acting on the simple shear connections of the infill beams. The existence of high shear loads was evident in many of the column tree beam stub cantilevers that formed diagonal tension field failure mechanisms in the cantilever webs, as seen in Figure 4-19.

The end bearing resistance of the beam web was less than the double shear strength of the high-strength bolts. An increased edge distance might have prevented this collapse by increasing the connections' tensile strength. The failure most likely began on the 8th floor and progressed downward, because the 9th floor did not collapse. The 4th floor and those below remained intact.

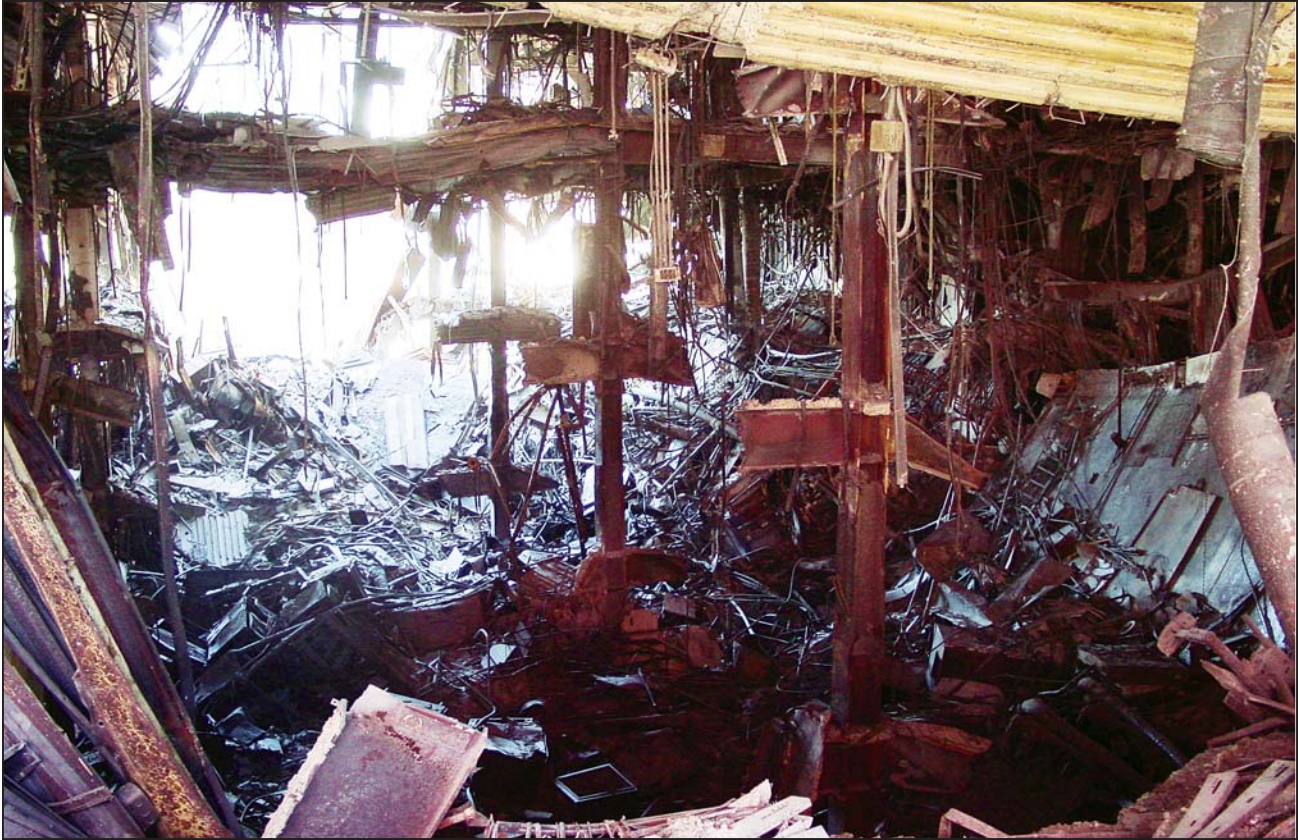
Figure 4-20 Internal collapsed area in WTC 5.

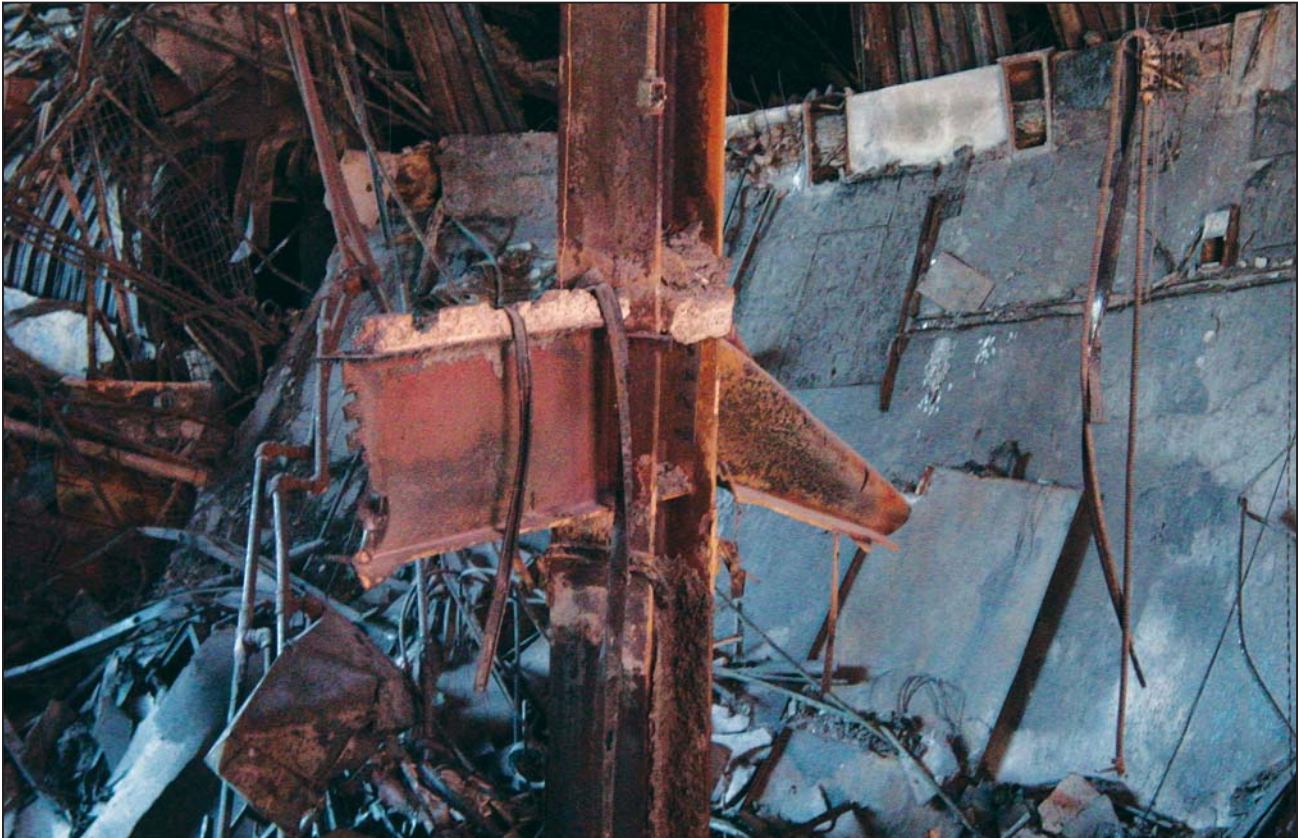
Figure 4-21 Internal collapsed area in WTC 5 with closeup of connection failure at column tree.

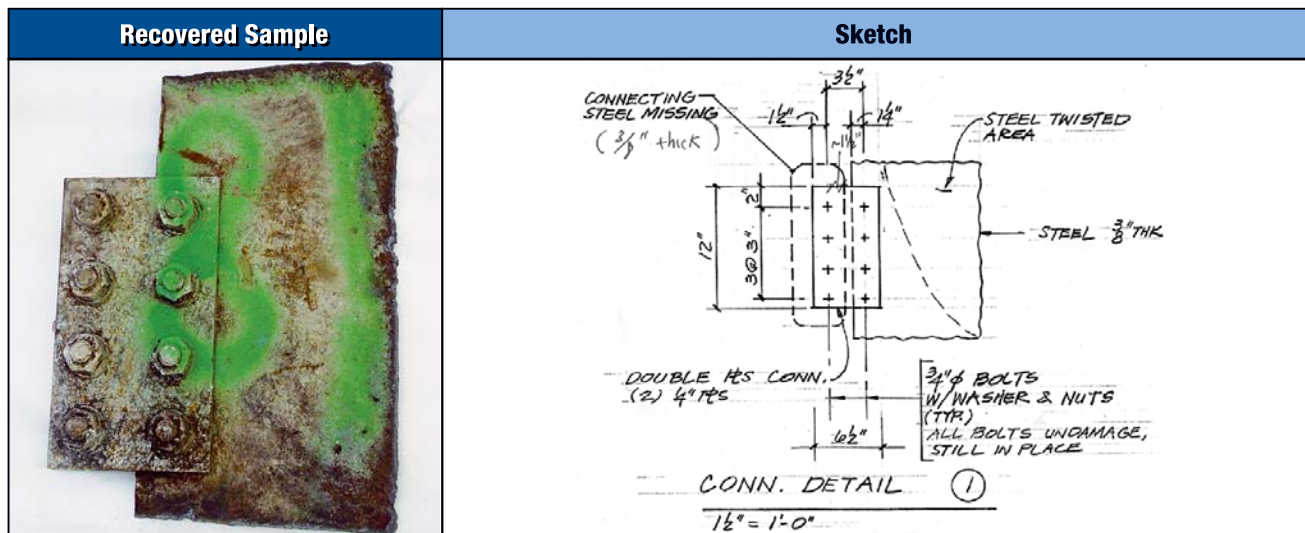
Recovered From: WTC 5, 8th Floor

Steel framing connection samples were recovered from floors 6, 7, and 8 of WTC 5 with the aid of the New York Department of Design and Construction (DDC) and are described in Figure 4-22. These samples have not been analyzed and are being preserved for future study. The photographs of connection samples in Figure 4-22 indicate that the deformed structure subjected the bolted shear connection to a large tensile force. At 550 °C (1,022 °F), the ultimate resistance of the three bolts is about 45 kips. The capacity increases to approximately 90 kips at room temperature. Connection failure likely occurred between these bounds.

Failure Mode: Web tear-out at bolts

Figure 4-22 Connection samples.

- There is insufficient understanding of the performance of connections and their adequacy under real fire exposures as discussed in Appendix A. This is an area that needs further study. The samples discussed in Section 4.3.2 should be useful in such a study.
- A determination of the combined structural and fire properties of the critical structural connections should be made to permit prediction of their behavior under overload conditions. This can be accomplished with a combination of thermal transfer modeling, structural finite element modeling (FEM), and full-scale physical testing.

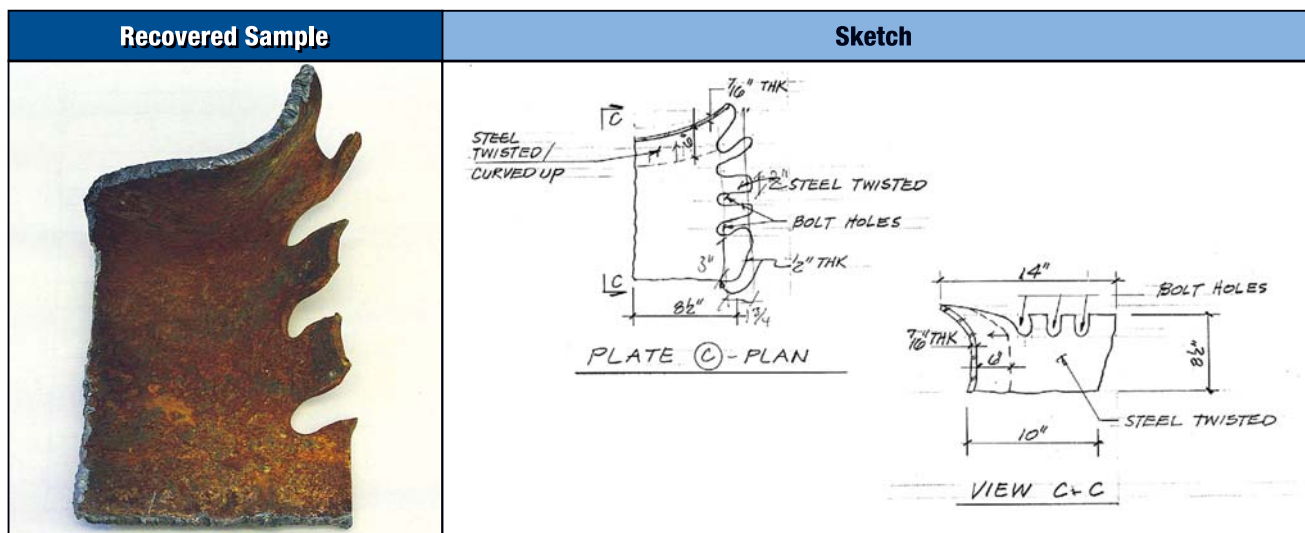
Recovered From: WTC 5, 7th Floor

Failure Mode: Web tear-out at bolts

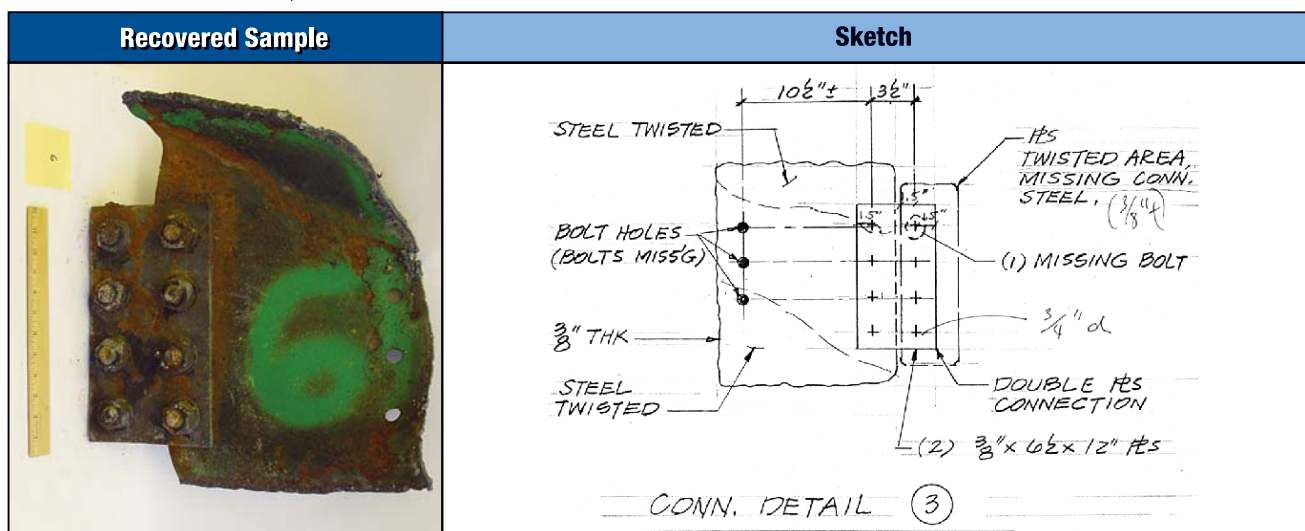
Recovered From: WTC 5, 6th Floor

Failure Mode: Web tear-out at bolts

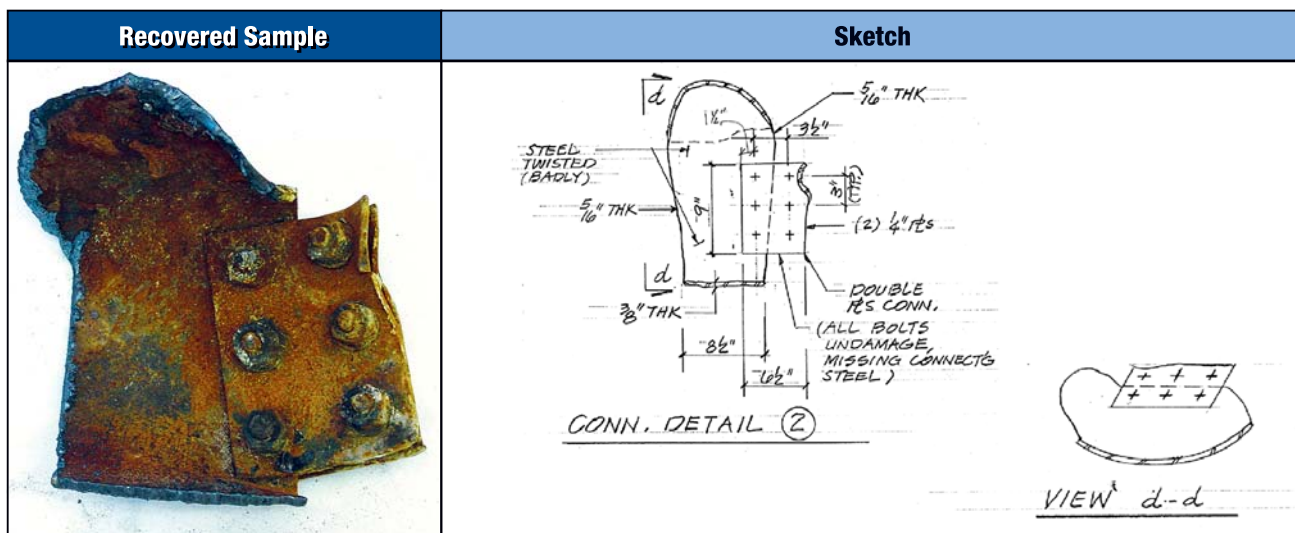
Recovered From: WTC 5, 6th Floor

Failure Mode: Web tear-out at bolts

Figure 4-22 Connection samples (continued).

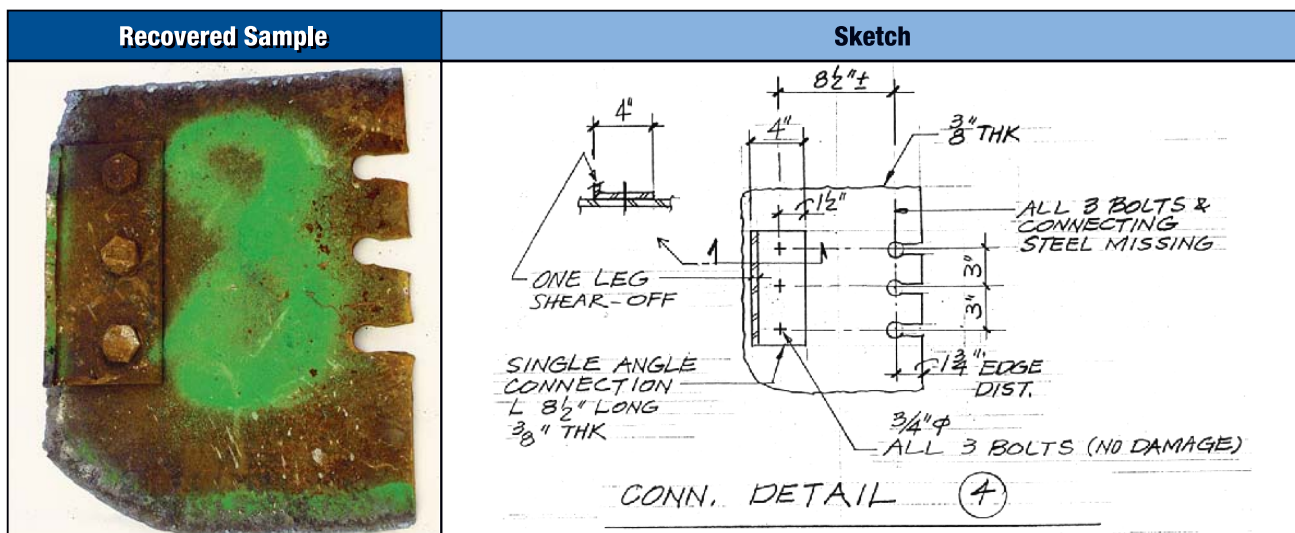
Recovered From: WTC 5, 8th Floor

Failure Mode: Plate tear-out at bolts

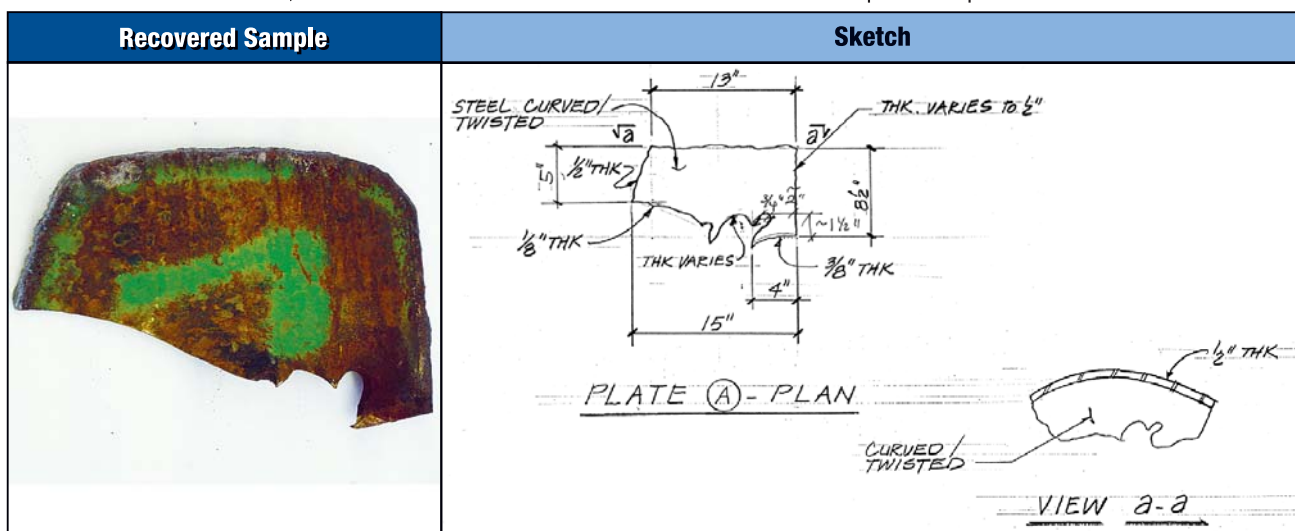
Recovered From: WTC 5, 7th Floor

Failure Mode: Connection web plate or splice block shear

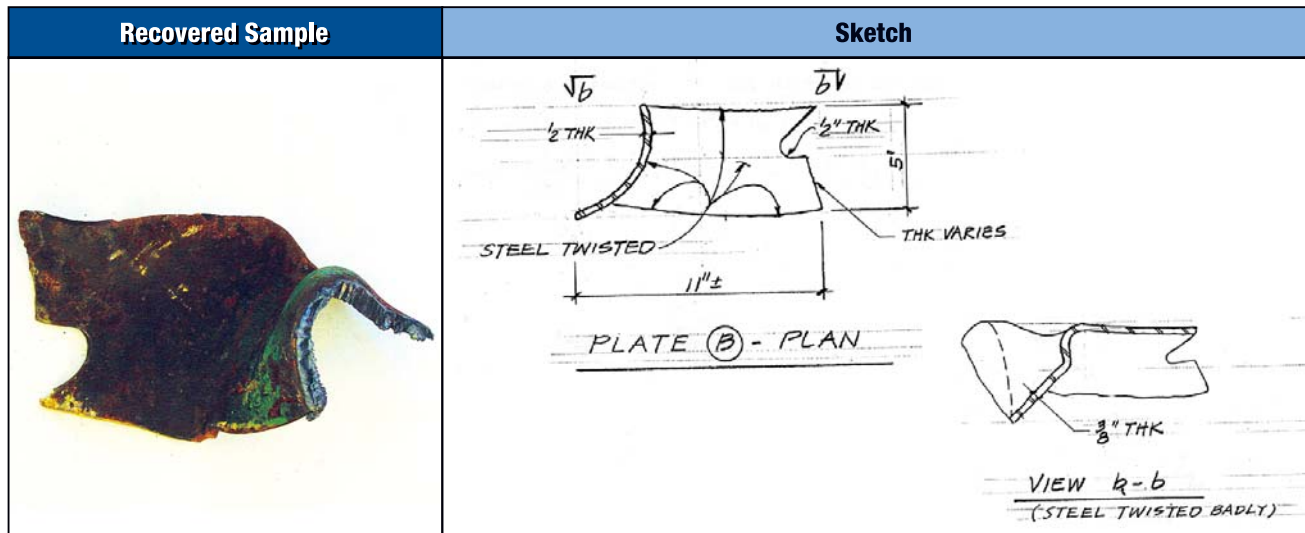
Recovered From: WTC 5, Floor undetermined**Failure Mode:** Column buckling due to heat exposure

Figure 4-22 Connection samples (continued).

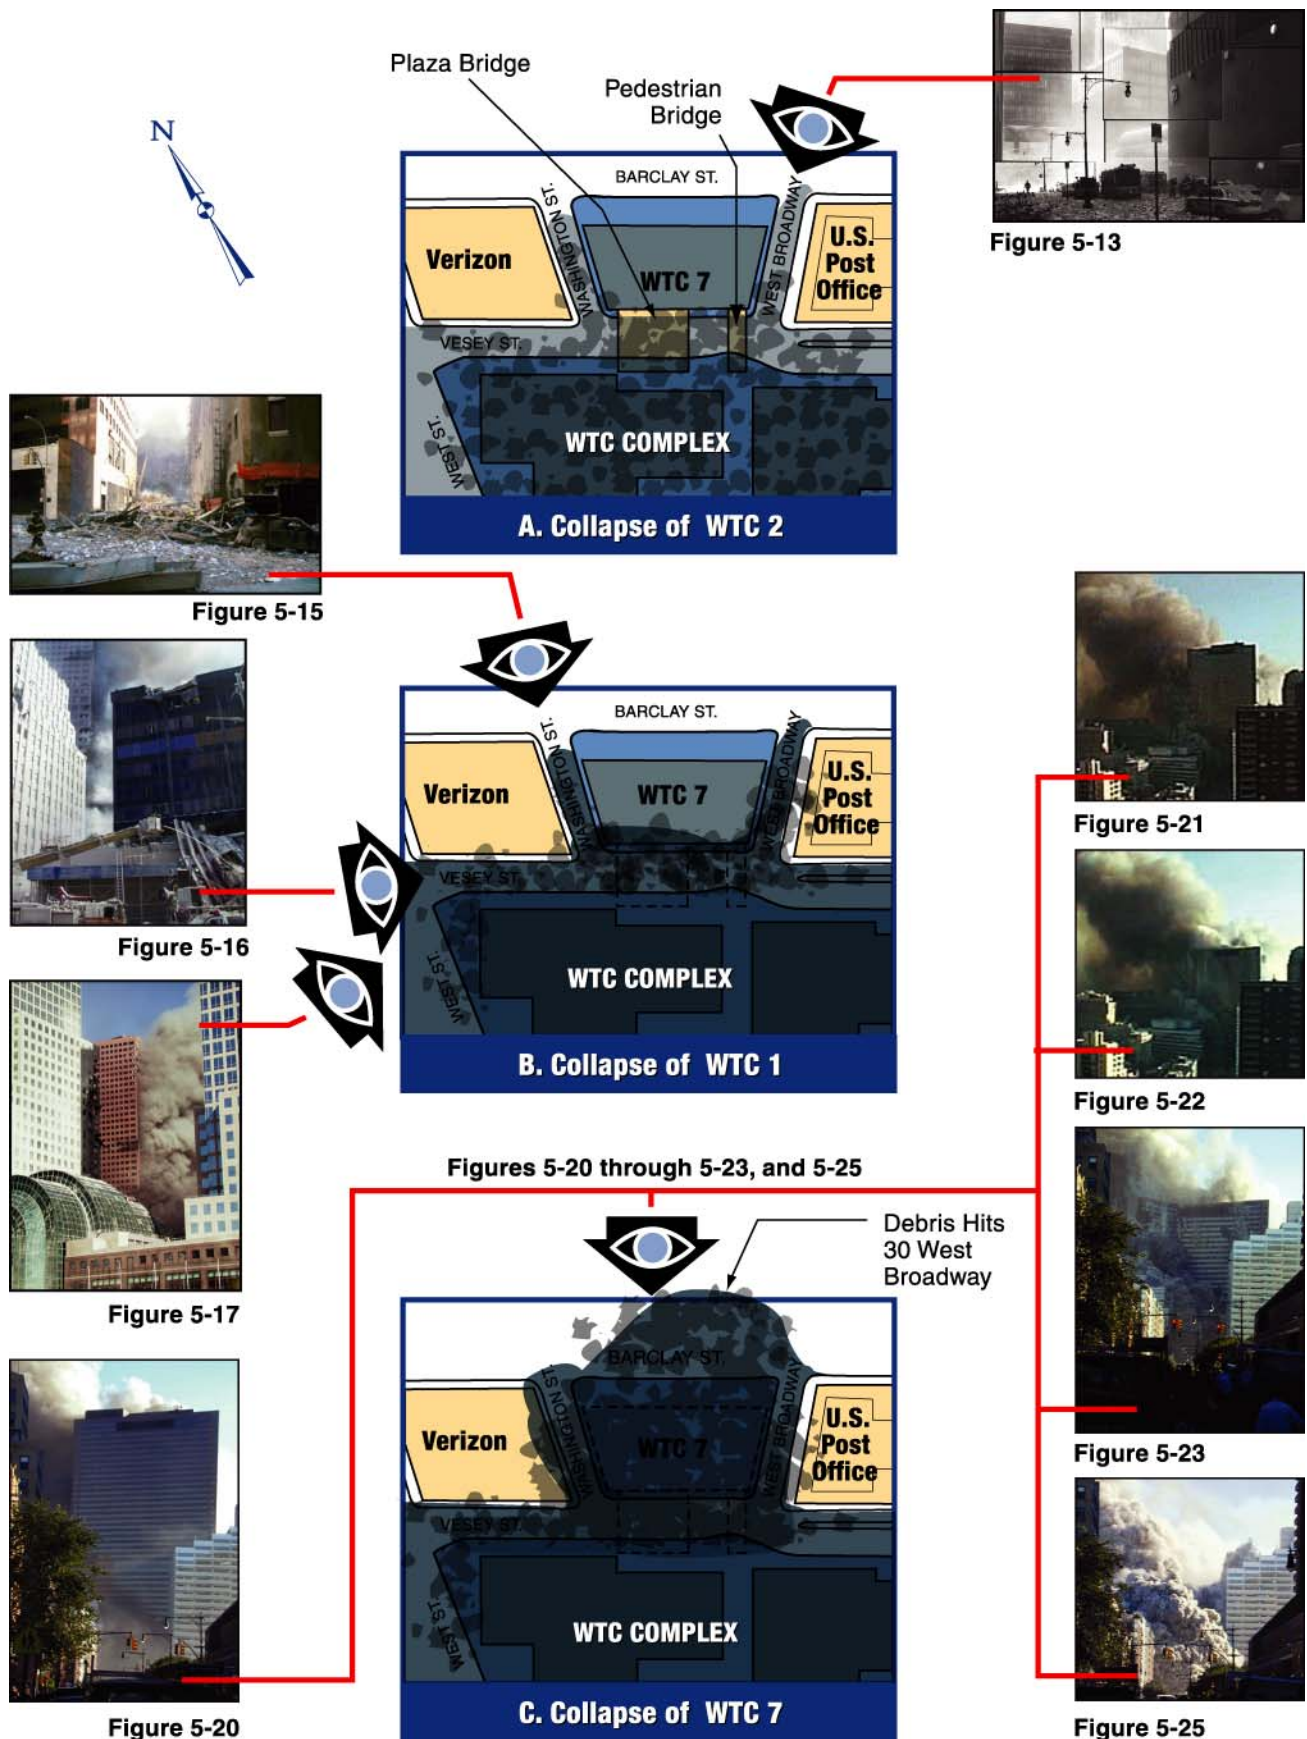
Figure 5-14 is an aerial photograph that shows the debris clouds spreading around WTC 7 just after the collapse of WTC 1. Figure 5-15 is a photograph of WTC 1 debris between the west elevation of WTC 7 and the Verizon building. Figure 5-12(B) shows a plan-view diagram approximating the extent of this debris just after the collapse of WTC 1.

Figure 5-12 Sequence of debris generated by collapses of WTC 2, 1, and 7.

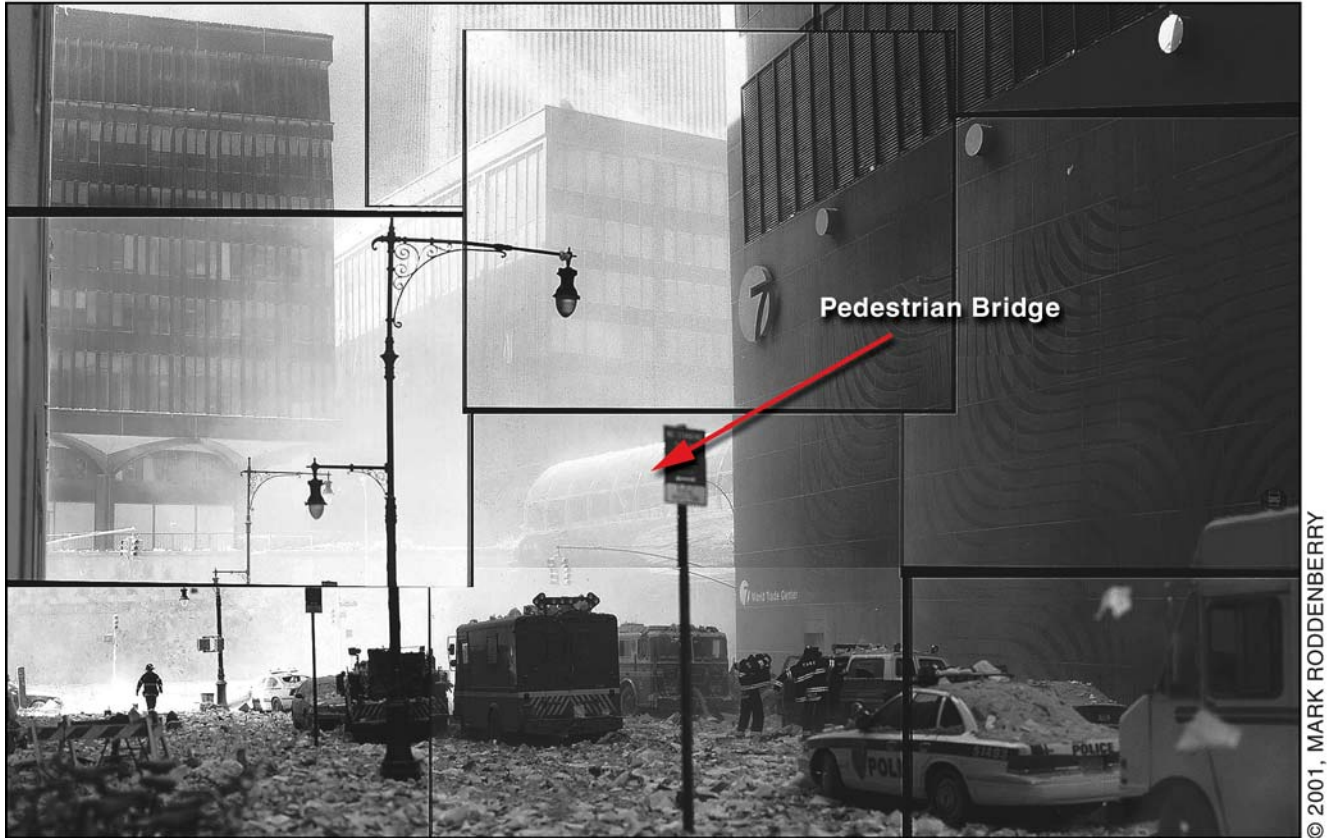
Figure 5-13 Pedestrian bridge (bottom center) still standing after WTC 2 has collapsed, sending substantial dust and debris onto the street, but before WTC 1 (top center) has collapsed.
